Comparative Study of Corrosion Behavior of AA2014/15 Vol% Al₂O₃p and AA2009/20 Vol% SiCw

Abstract

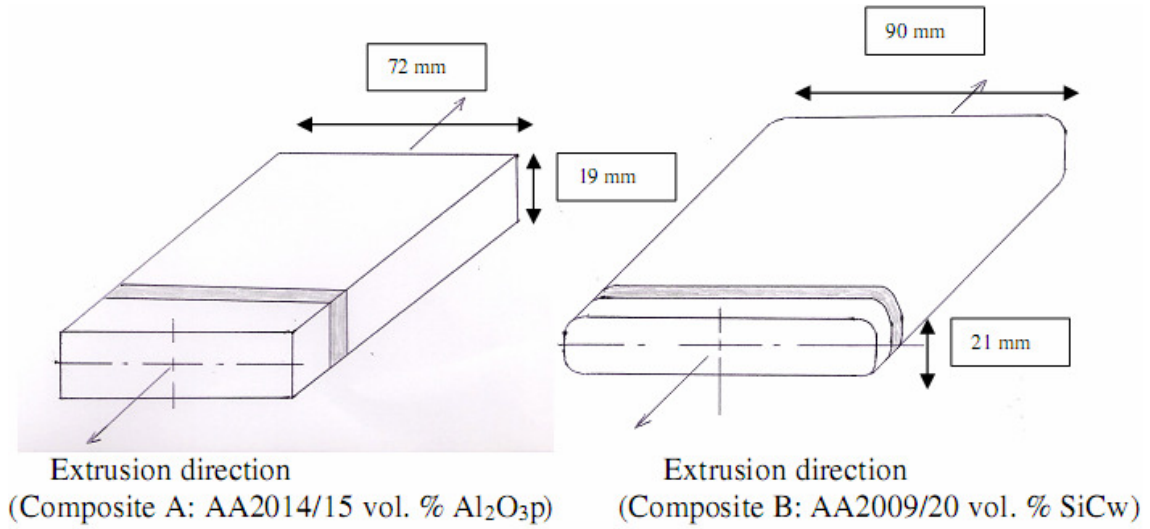
Figure 1. Schematic diagram of as-received bar of the composites from the suppliers.

Composite A was supplied by Duralcan Inc., San Diego, California, USA, and produced by casting method followed by hot extrusion process to form rectangular bar with 77 mm wide and 19 mm thickness (Fig. 1). Composite B was supplied by Advanced Composite Materials Corporation (ACMC), USA. Composite B was fabricated by powder metallurgy method followed by hot extrusion process to form a rectangular fillet bar with 90 mm wide and 21 mm thickness (Fig. 1).

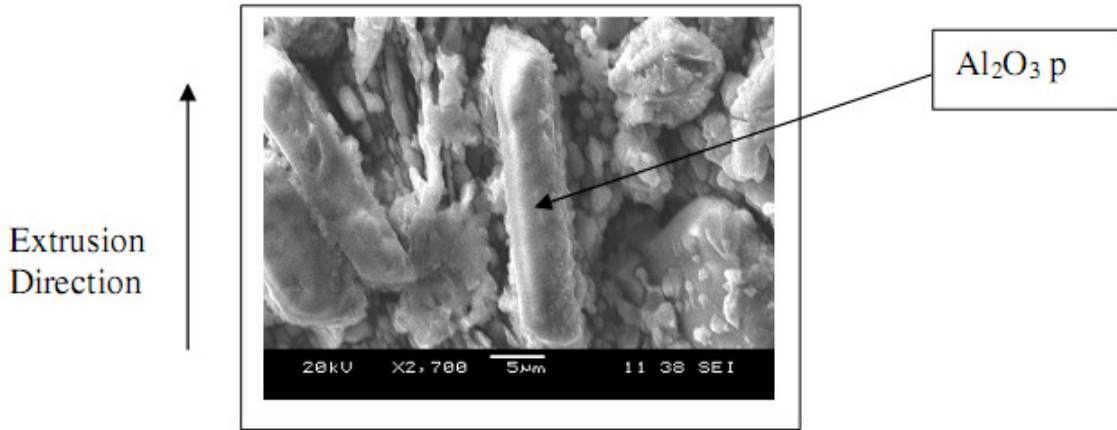
Figure 2. SEM micrograph of composite A: A2014/15%Al₂O_{3p}, parallel to the extrusion direction.

Fig. 2 shows the microstructure of composite A: AA2014/15%Al₂O₃p, parallel to the extrusion direction. Etching with an acid solution (HCl/HNO₃=1:1) reveals the grain boundaries in the matrix. The particles are moderately aligned to the extrusion direction and homogeneously distributed. Fig. 3 shows the microstructure of composite B: AA2009/20%SiCw parallel to the extrusion direction. Etching with an acid solution (HCl/HNO₃=1:1) reveals the whiskers in the matrix. The whiskers are moderately aligned to the extrusion direction and homogeneously distributed.

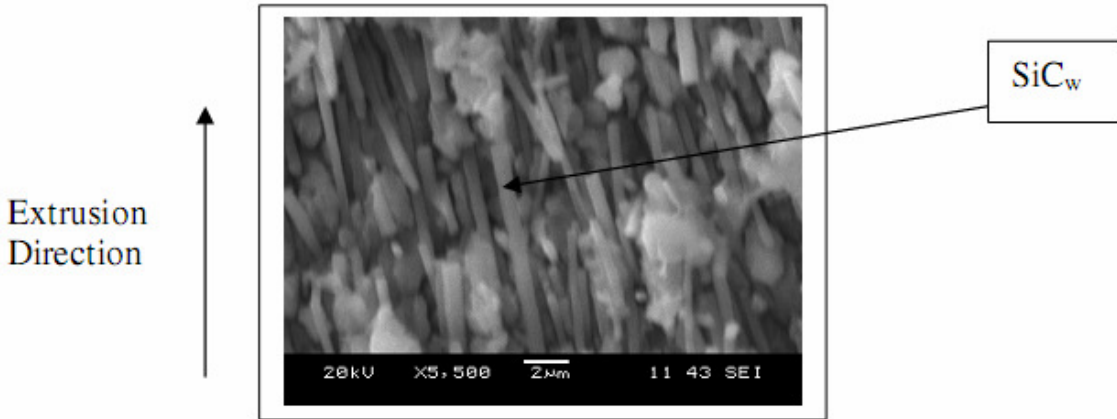
Figure 3. SEM micrograph of composite B: Al2009/20%SiCw parallel to the extrusion direction.

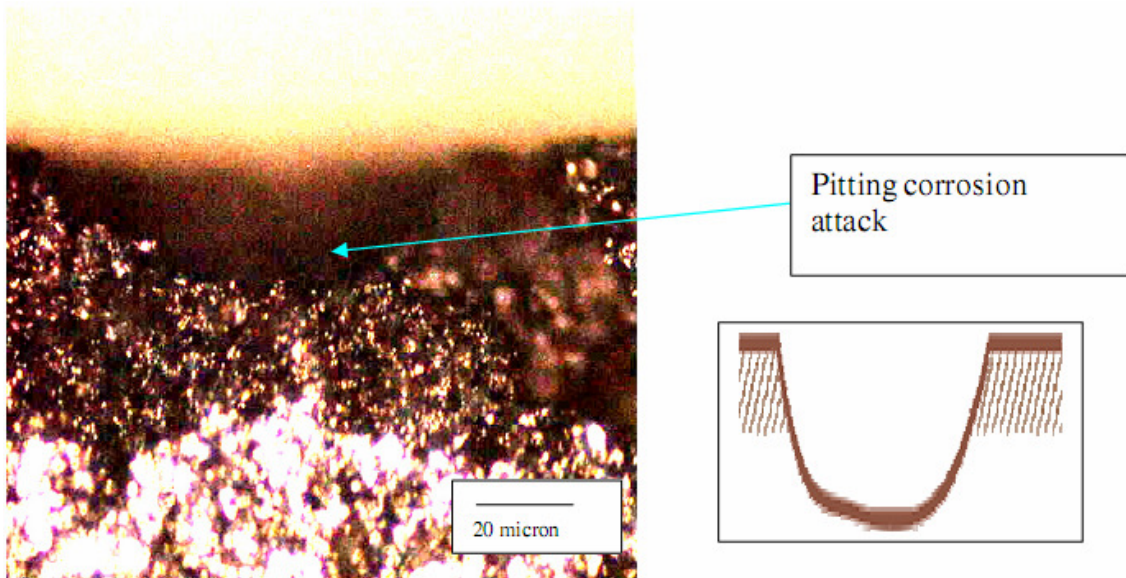
Figure 4(a). Pitting corrosion attack in the matrix through the interface $\text{Al}_2\text{O}_3\text{p}$ /matrix in composite A (AA2014/ $\text{Al}_2\text{O}_3\text{p}$ /15% (T6) MMC) in shallow wide pit shape.

Figs. 4 to 5 show the pitting corrosion attack after 28 days immersion in 3.5% NaCl for both composites. The pitting corrosion attacks the matrix through the interface reinforcement/matrix in different pit shape. Figs. 4(a) and 4(b) indicate pitting corrosion attacks after 28 days immersion in the composite A. The pitting corrosion attacks the matrix through the interface $\text{Al}_2\text{O}_3\text{p}$ /matrix indicating shallow wide pit shape and vertical grain attack pit shape. Figs. 5(a) and 5(b) indicate pitting corrosion attacks after 28 days immersion in the composite B through the interface SiCw/matrix and indicating shallow deep pit shape. It was

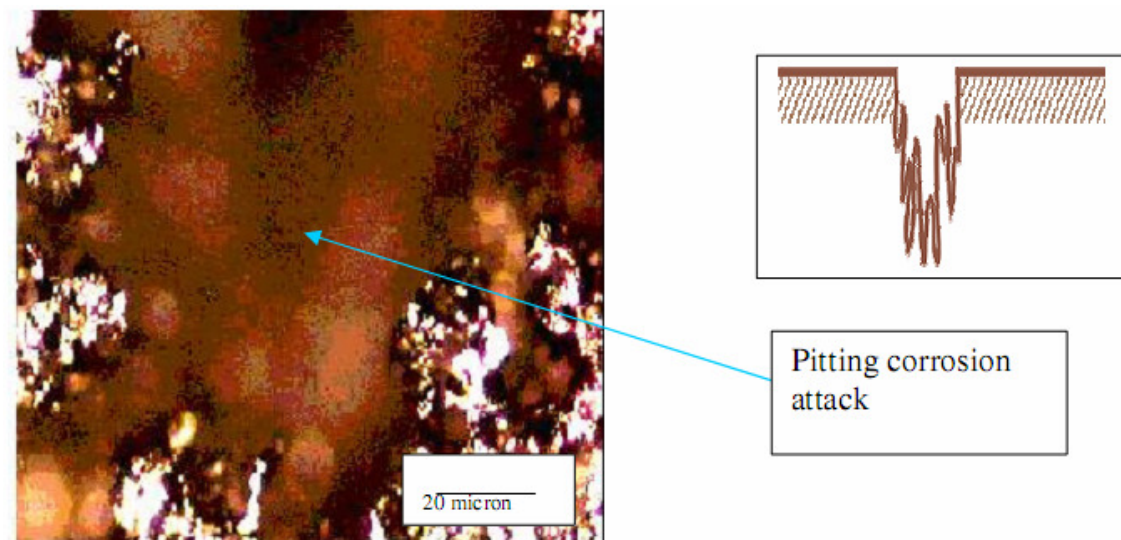
Figure 4 (b). Pitting corrosion attack in the matrix through the interface $\text{Al}_2\text{O}_3\text{p}$ /matrix in composite A (AA2014/ $\text{Al}_2\text{O}_3\text{p}$ /15% (T6) MMC) in vertical grain attack pit shape.

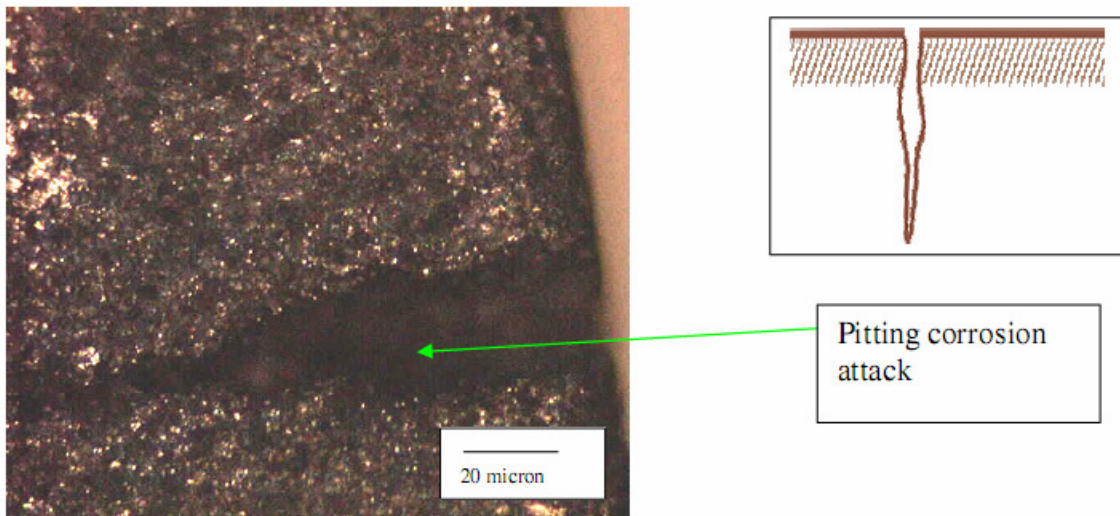
Figure 5(a). Pitting corrosion attack in the matrix through the interface SiCw/matrix in composite B (AA2009/SiCw /20% (T6) MMC) in shallow deep pit shape.

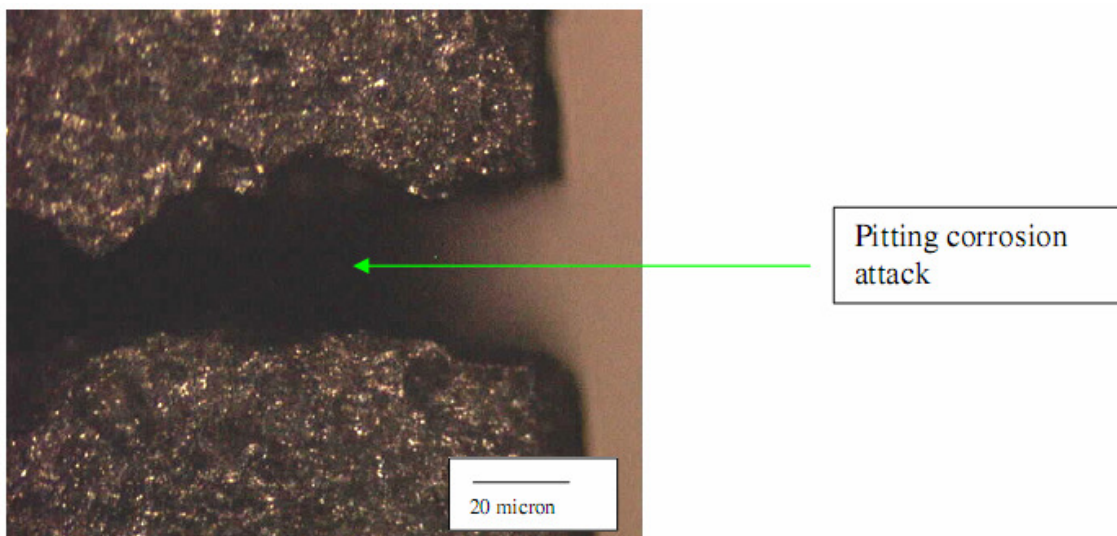
Figure 5(b). Pitting corrosion attack in the matrix through the interface SiC/matrix in composite B (AA2009/SiC w /20% (T6) MMC) in shallow deep pit shape.

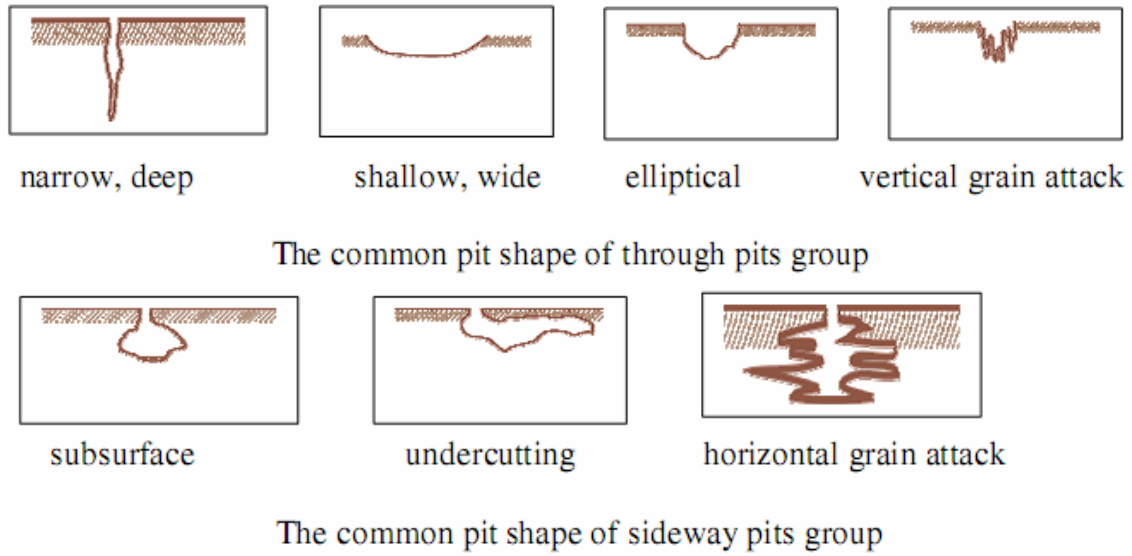
Figure 6. Common pit shape of through pits group and sideway pits group [17].

virtually unaffected. The following are common pits shape divided in two groups, as shown in Fig. 6.

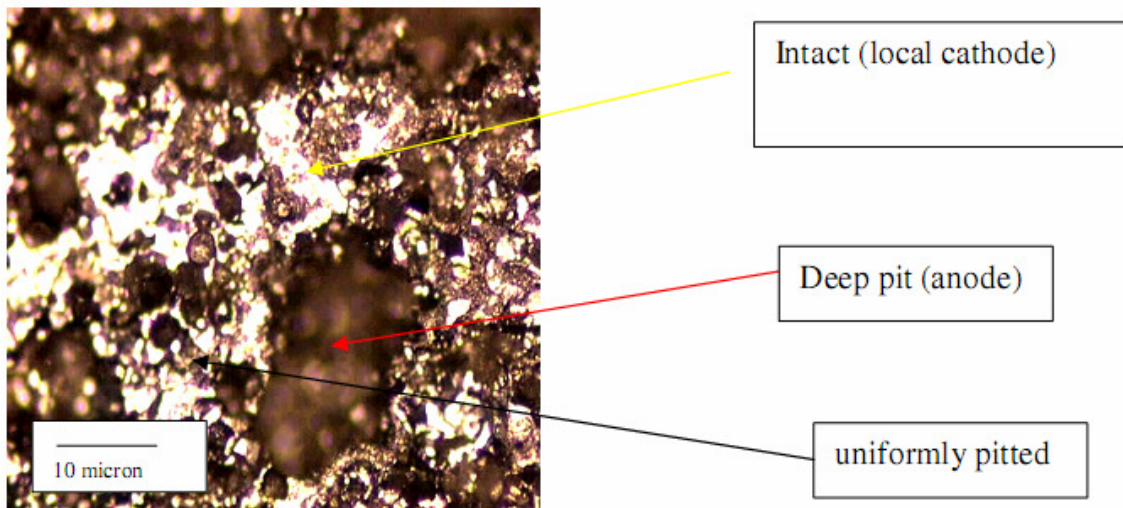
Figure 7. Holes due to an intensive matrix corrosion in composite A (AA2014/ Al_2O_3p /15%p (T6) MMC).

Figs. 7 and 8 show the holes due to the intensive matrix corrosion in the composites A and B. This example of a pitted surface was produced by exposing a sample to a 3.5% NaCl during 28 days. Most of the surface is uniformly pitted (black arrow), as both composites would do in similar conditions. It is seen the formation of deeper pits (red arrow) that are surrounded by un-attacked regions (yellow arrow). However, the main reason for their poor corrosion resistance is attributed to the crevices at the Al_2O_3/Al interface and $SiCw/Al$ interface as preferential site of attack, as shown in Figs. 7 and 8.

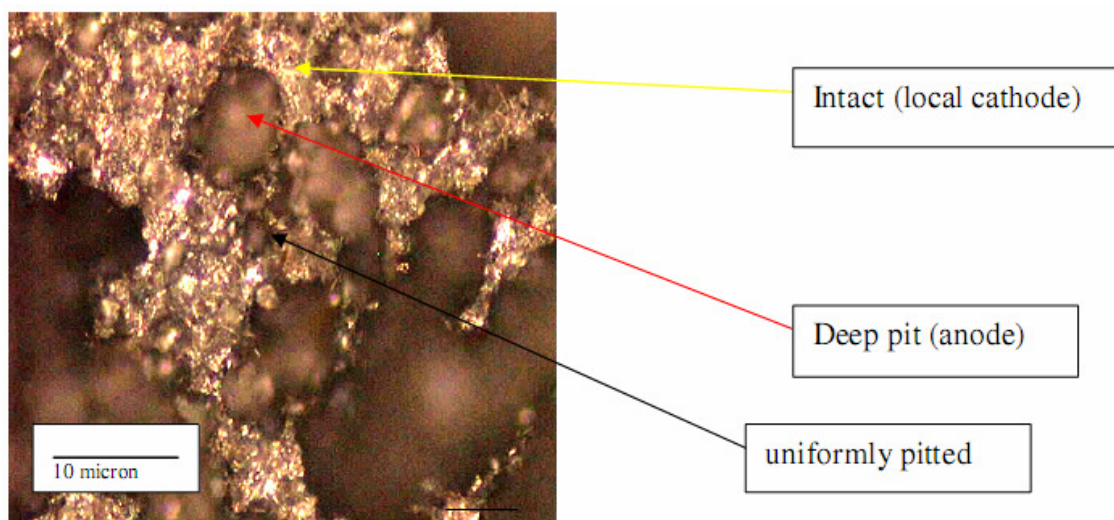
Figure 8. Holes due to an intensive matrix corrosion in composite B (AA2009/SiC/20%w (T6) MMC).
